Errata Sheet

Rel. 1.4, 12.11.2009

Device	**TC1167**
Marking/Step	**QS-AD**
Package	**PG-LQFP-176-5**

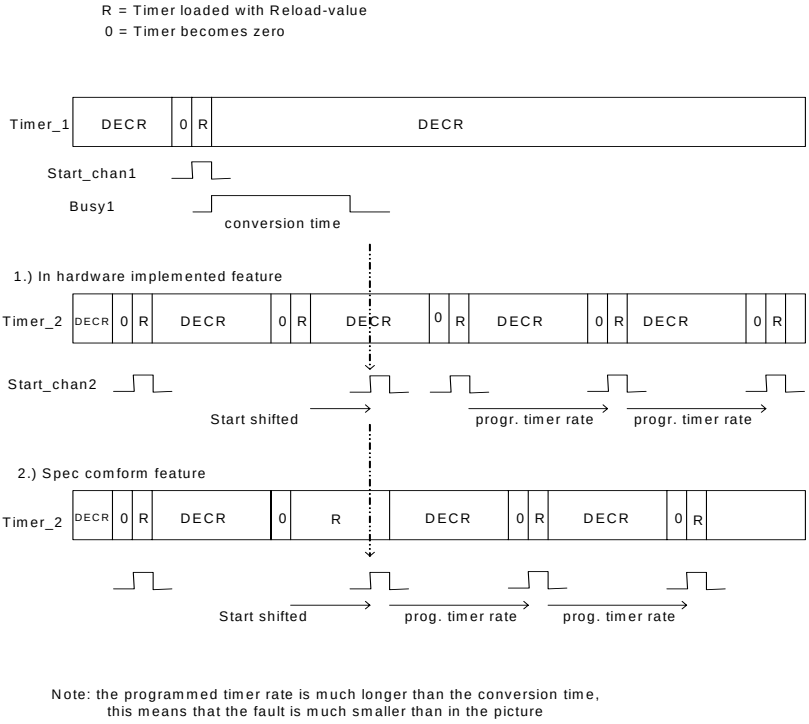
Figure 1 Timing concerning equidistant multiple timers

The correct behavior would be a reload when the requested conversion (of channel_2) is started.

Therefore the start of conversion for channel_2 is delayed by maximum one conversion-time. After this delay it will be continued with equidistant conversion-starts. Please refer to the following figure.

Note: the programmed timer rate is much longer than the conversion time, this means that the fault is much smaller than in the picture

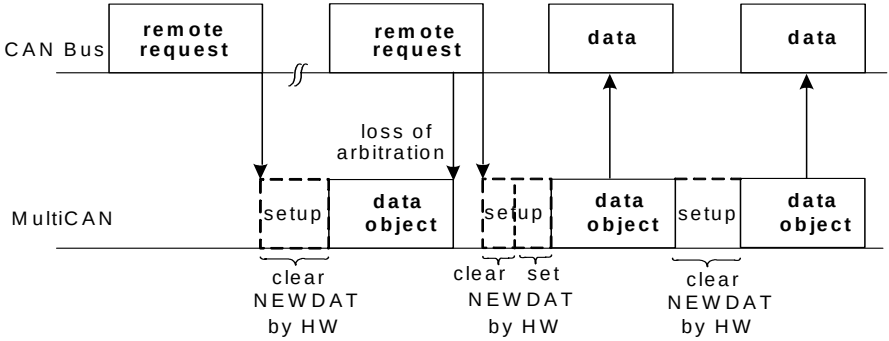
Figure 2 Loss of Arbitration

When the appropriate message object (data frame) triggered by the first remote frame wins the arbitration, it will be sent out and NEWDAT is not reset. This leads to an additional data frame, that will be sent by this message object (clearing NEWDAT).

There will, however, not be more data frames than there are corresponding remote requests.
